Jackson Hole, Wyoming Environmental Restoration Feasibility Report

Feasibility Report
and
Appendixes A - B

Final
July 2000

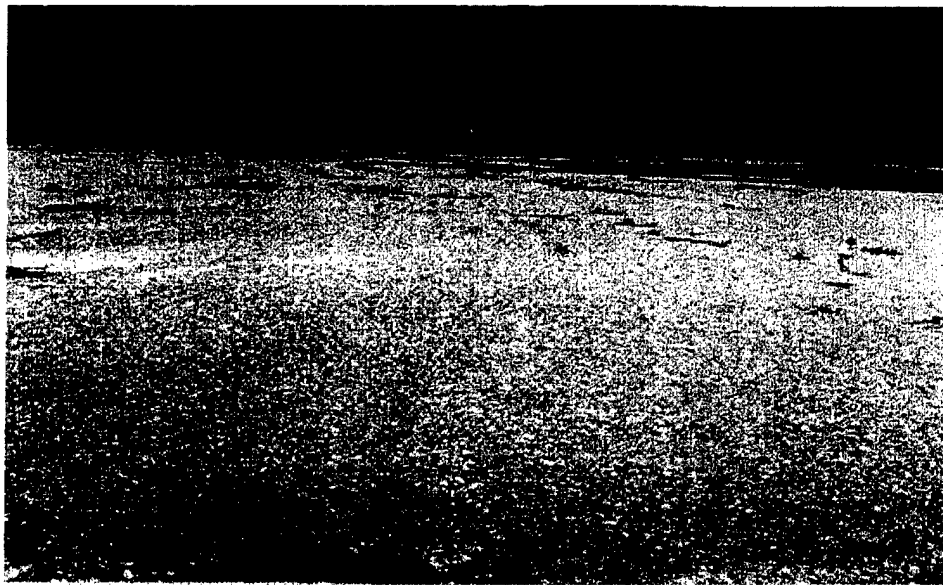
Aggradation of bedload material as indicated here was occurring in a number of areas along the leveed reach. Most notably in the Gros Ventre / Snake River confluence, at the Snake River Bridge, and at the lower end of the leveed reach.

It has been established through sediment range surveys first completed in 1954 that there are several sites along Snake River's levee reach that have experienced excessive aggradation of bedload material. This aggradation causes severe channel instability and diminished flood capacity in these areas.

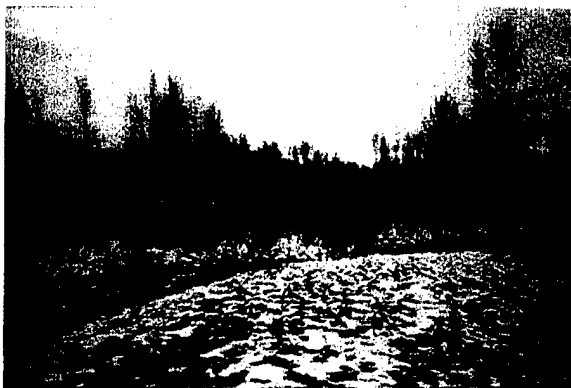
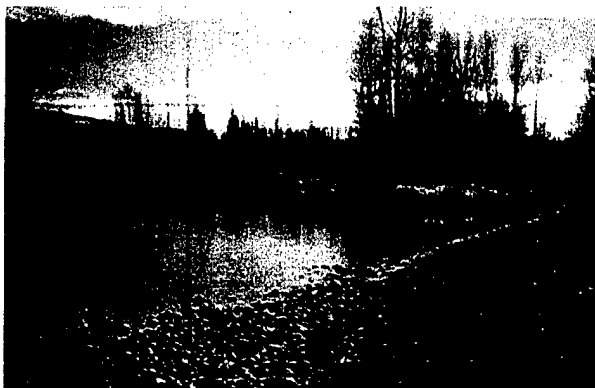
These "before and after" photos are of the middle pool area. This area is about midway down the secondary overflow channel on the island. The water shown in the left photo appeared during excavation and is being supplied by groundwater percolation. This minimal level was sustained throughout the winter.

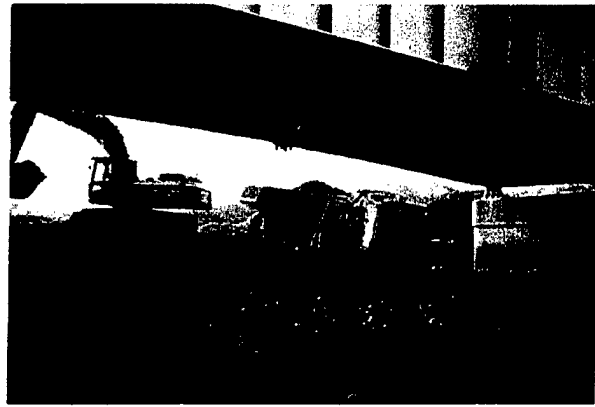
Channel management activity required additional heavy equipment in the immediate area of the Wilson Bridge. Aggradation of material was so excessive that the riverbed was lowered up to thirteen feet in this area. A small bulldozer was used to push the material out to the backhoe so that it could be loaded into the dump trucks

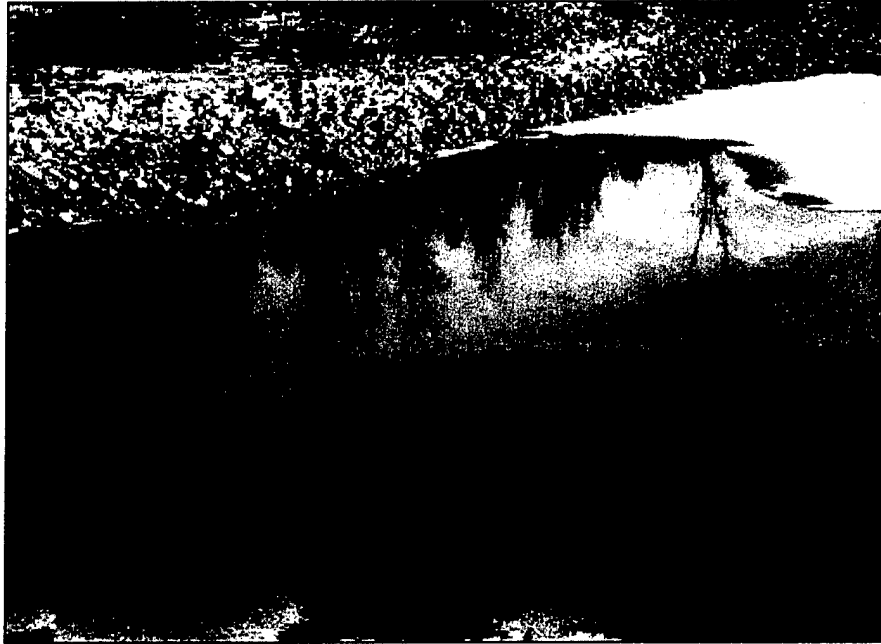
Pools like this one have formed near the river, thanks to the rehabilitation projects. One day, fish may use it as a spawning ground.

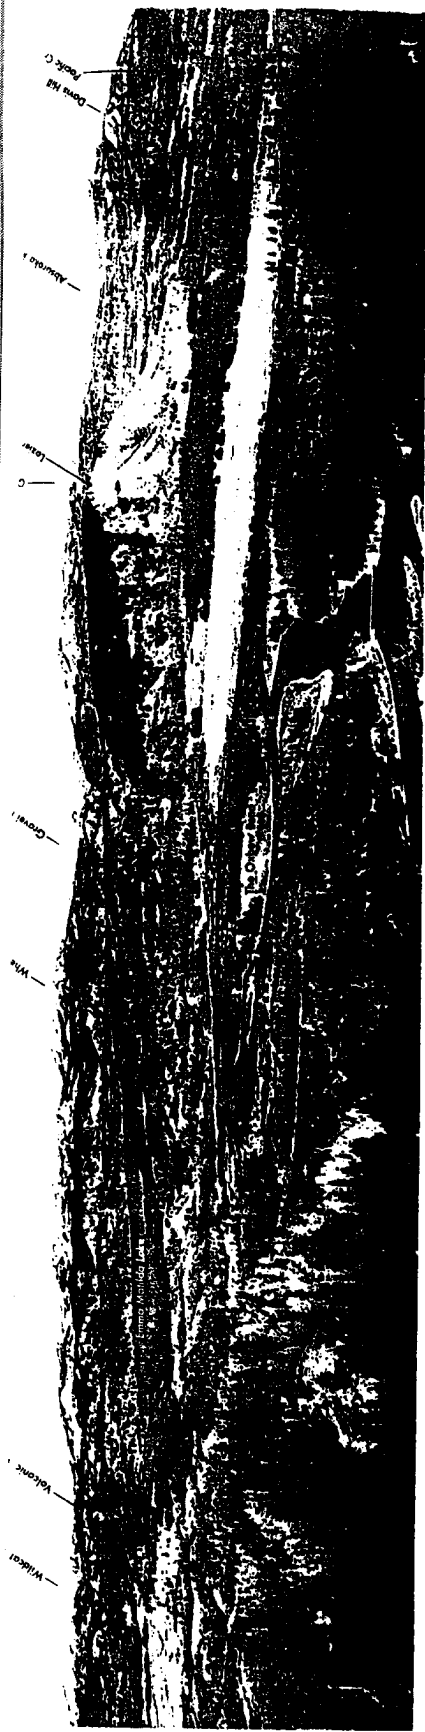
VIEW NORTHEAST FROM SUMMIT OF SIGNAL MOUNTAIN
Emma Matilda Lake is ponded behind glacial moraines. Most of the peaks and ridges are underlain by sedimentary rocks of Mesozoic and Tertiary age. Position of volcanic vent near Two Ocean Lake is indicated.

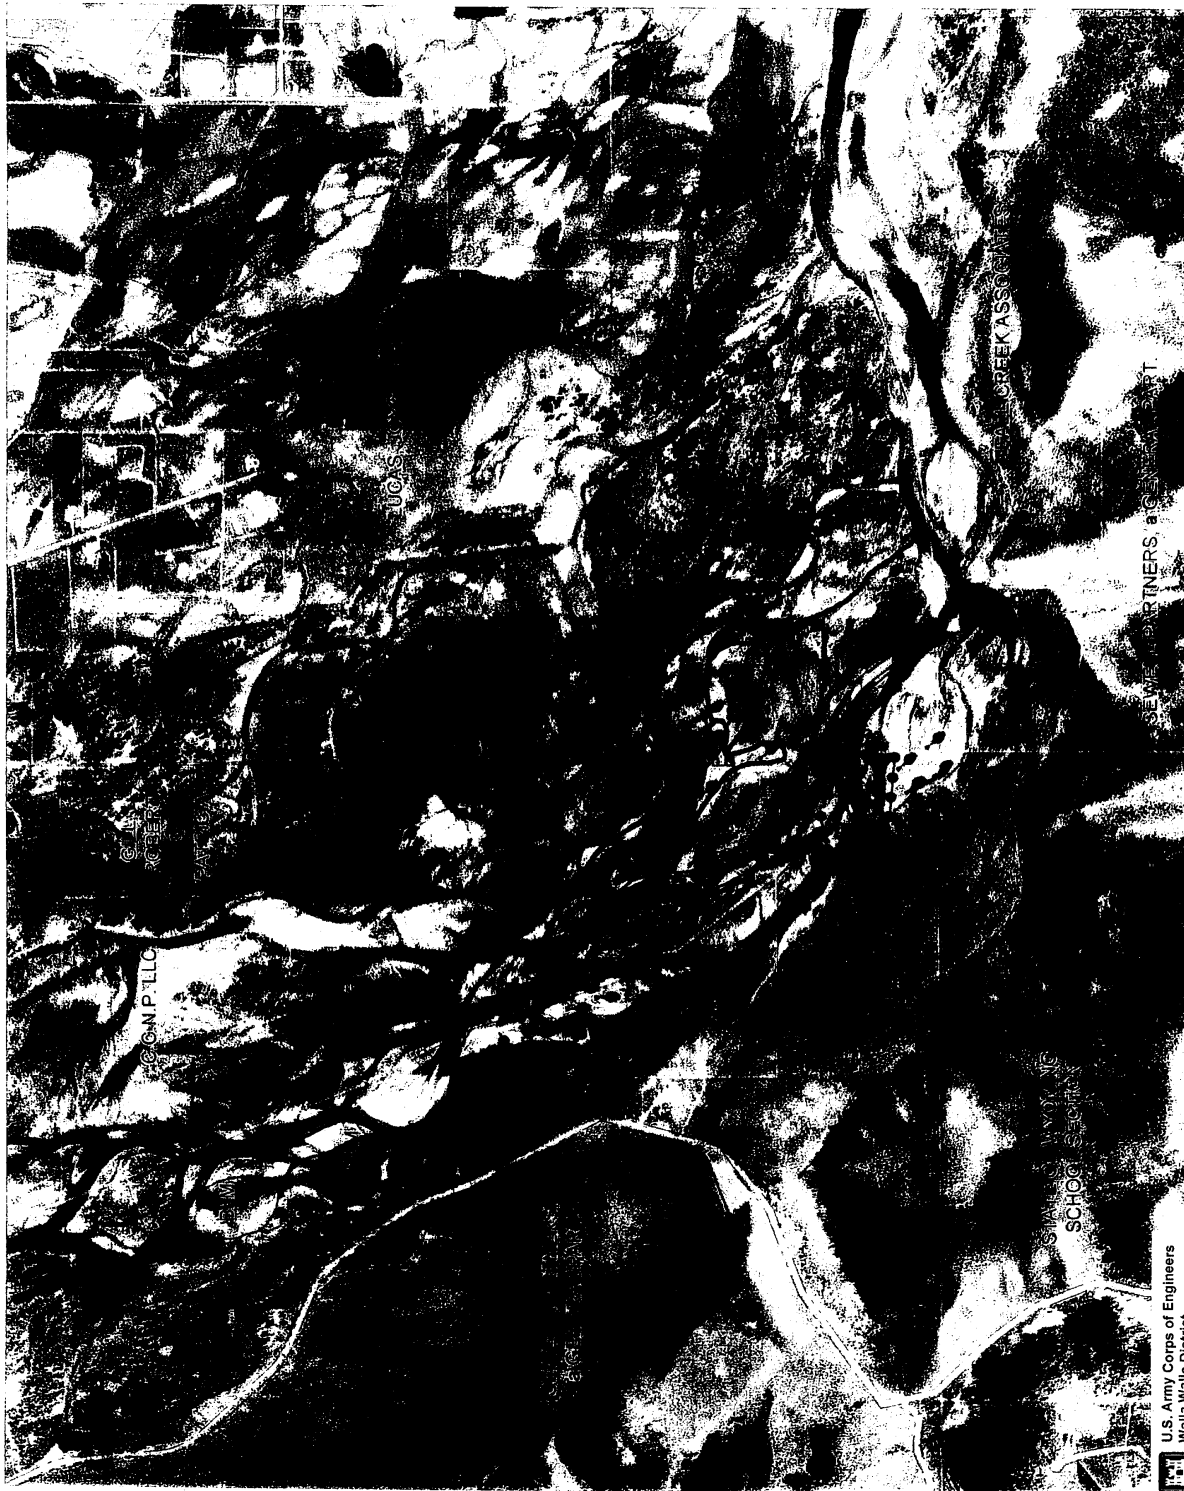
Jackson Hole, Wyoming
 Environmental Restoration Study
 December 1999
 Plate 16:
 Area 1 Plan

TEST PIT LOCATIONS	ANCHORED WOODY DEBRIS
SIDE POOLS	CHANNEL CAPACITY EXCAVATIONS
ECO FENCES	SUPPLY CHANNELS
	SEDIMENT POOL

1994 AERIAL PHOTOGRAPHY

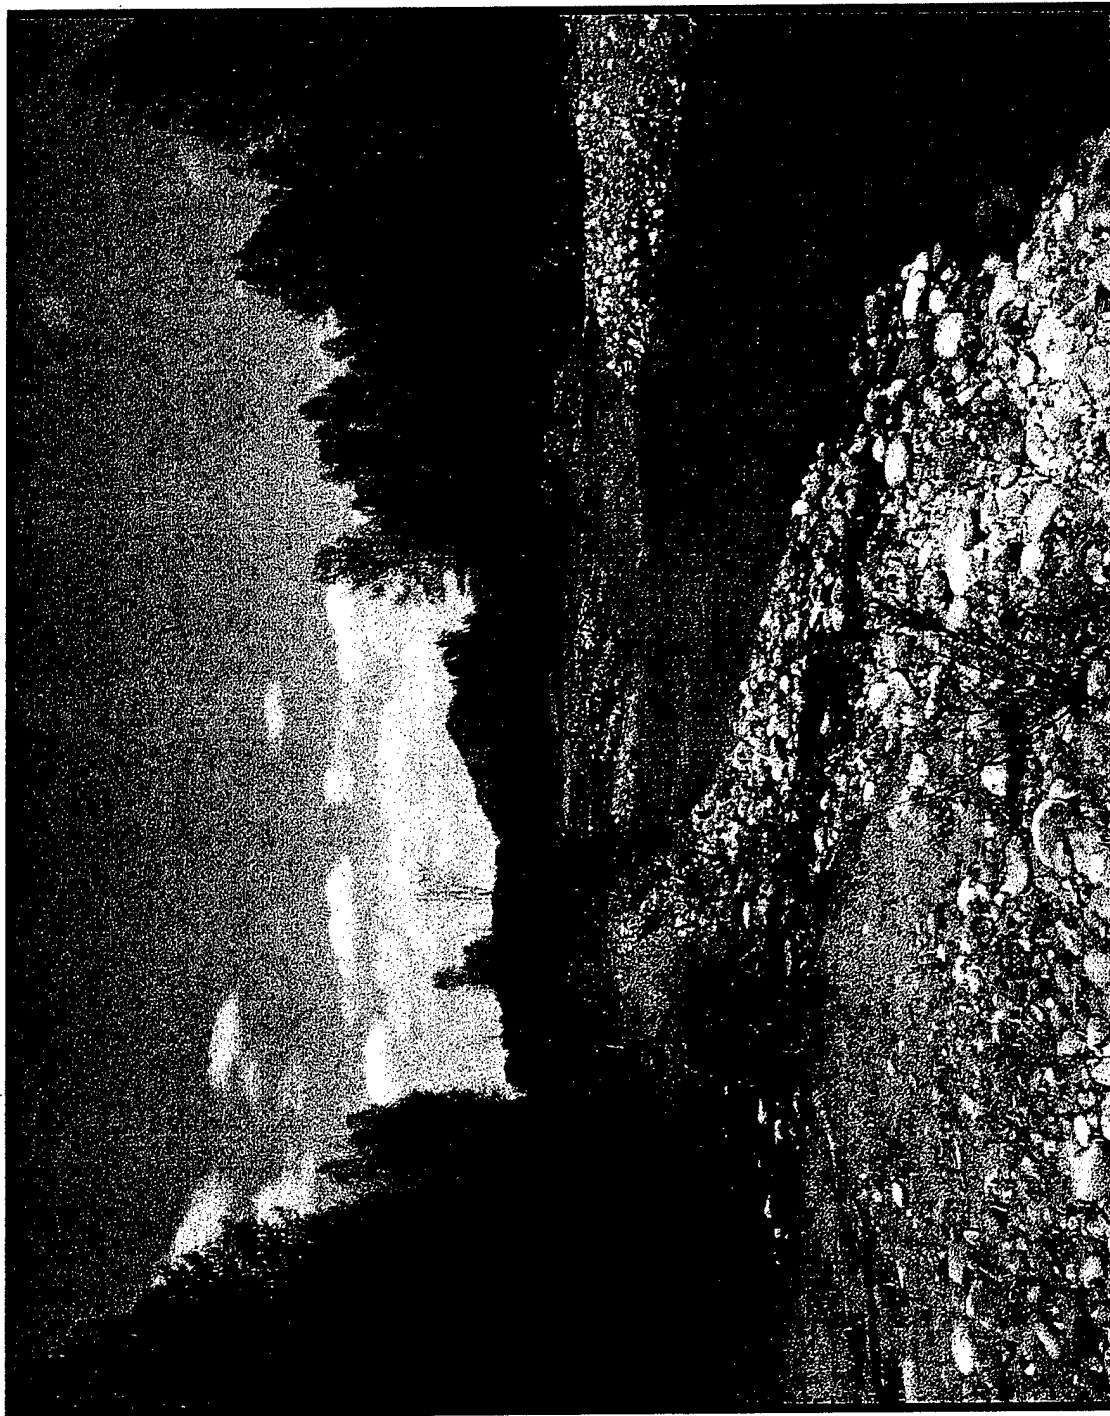
Plate 26:
Channel Capacity Excavation

Demonstration Project Site 9: Photo from 27 May, 1999; 14,000 cfs flow

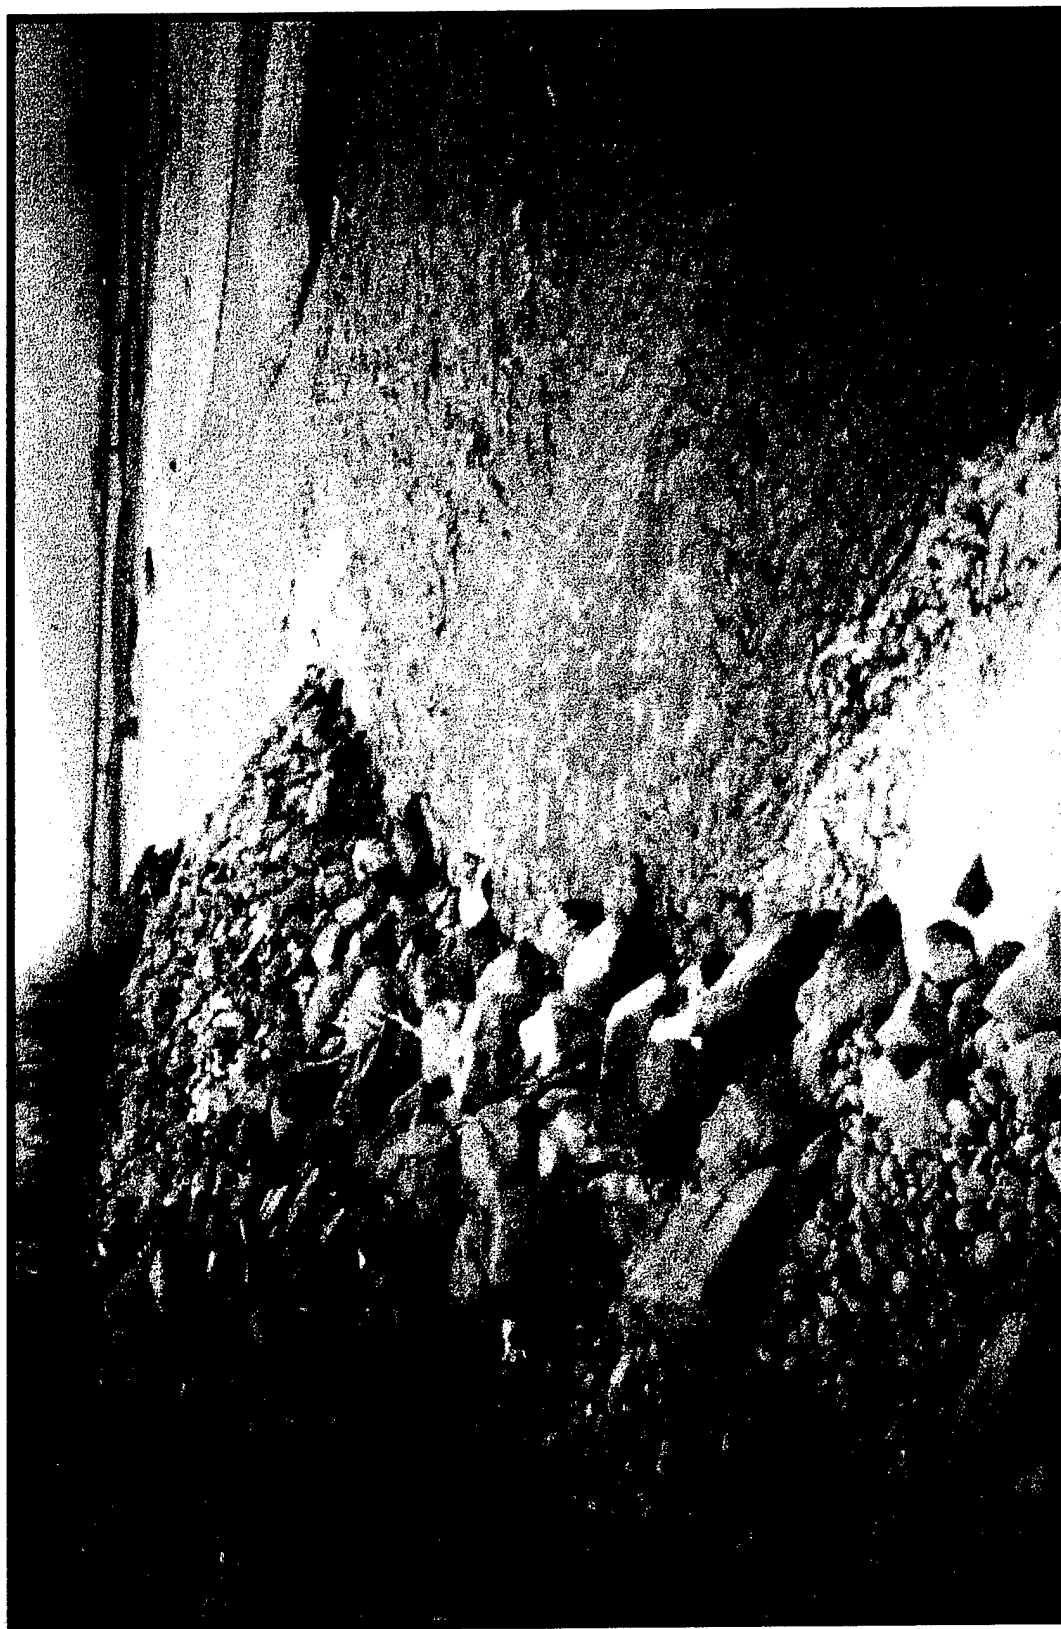
Plate 28:
Off-Channel Pool

Demonstration Project Site 9: Photo from November 1998; 5,000 cfs flow

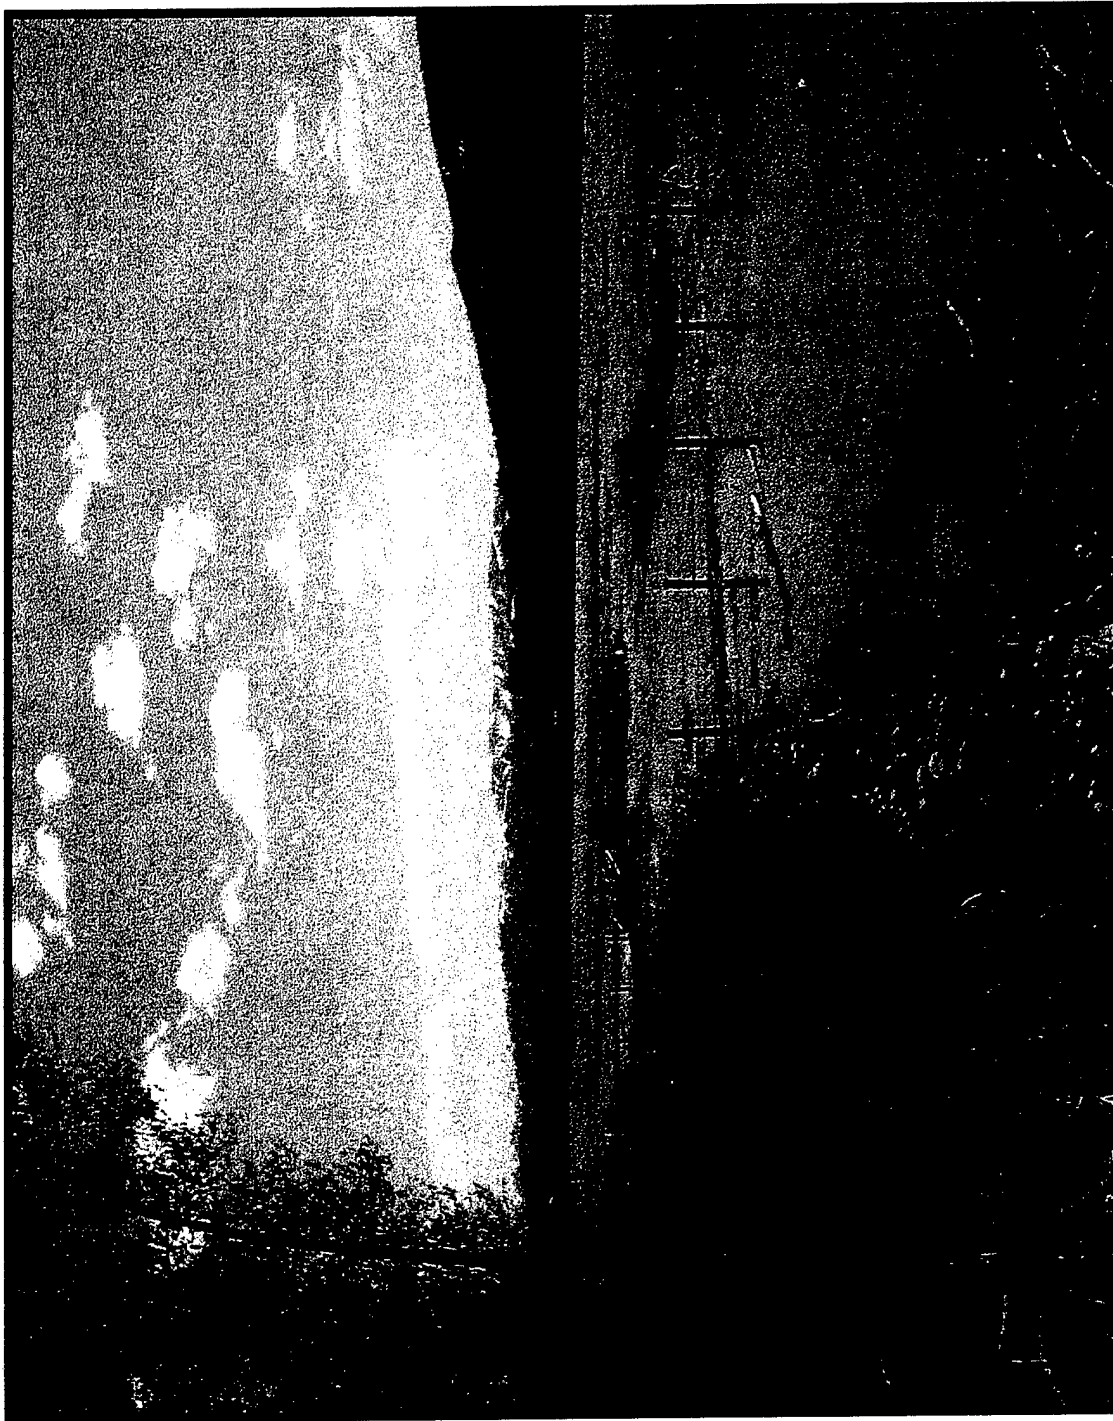
Plate 29:
Rock Spur Dike

Demonstration Project Site 9: Photo from 27 May, 1999; 14,000 cfs flow

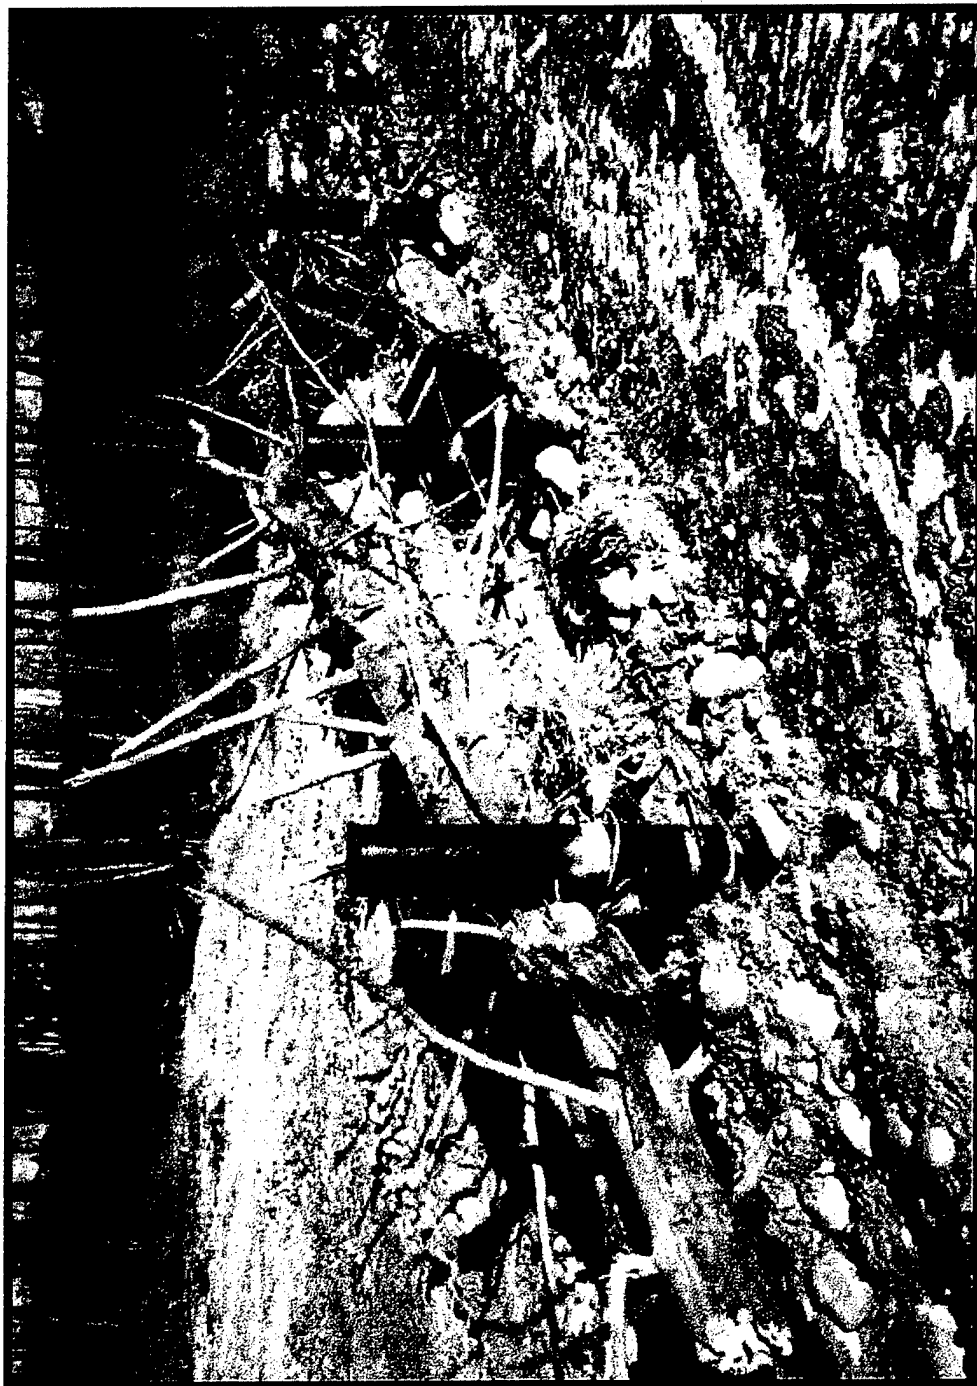
Plate 31:
Eco Fence with Debris

Demonstration Project Site 9: Post-construction photo from November, 1998

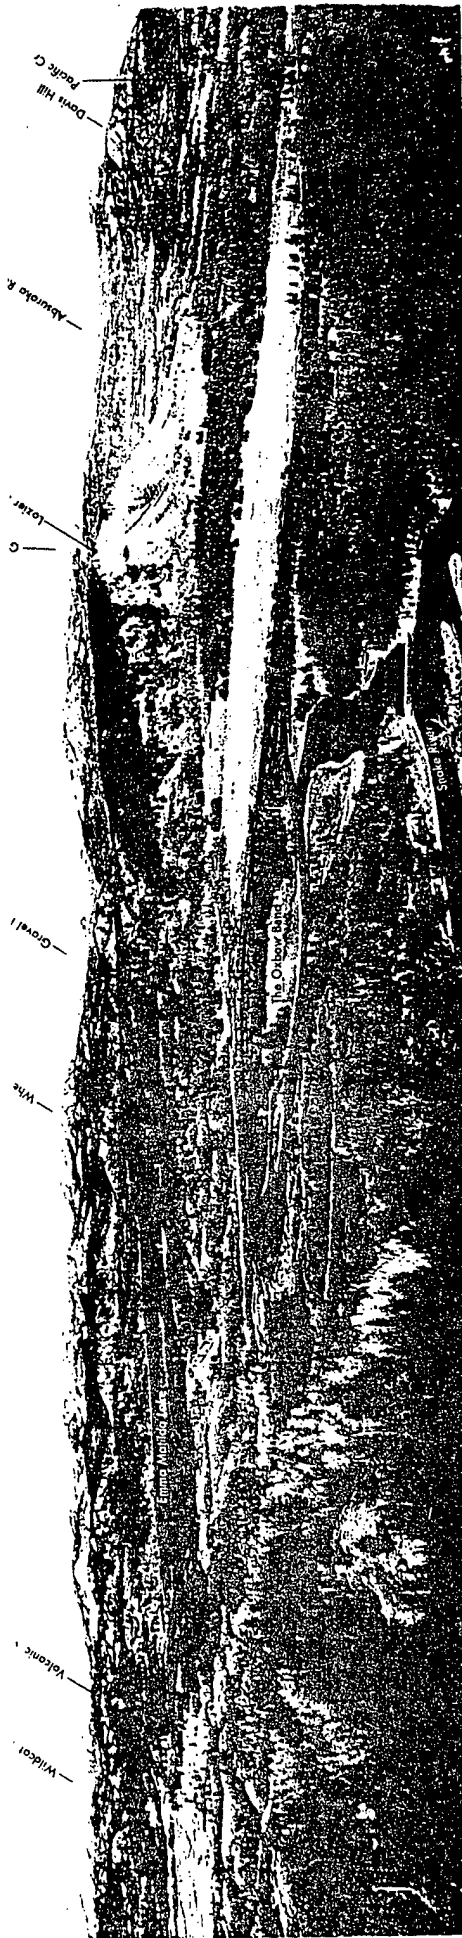
VIEW NORTHEAST FROM SUMMIT OF SIGNAL MOUNTAIN
Emma Matilda Lake is ponded behind glacial moraines. Most of the peaks and ridges are underlain by sedimentary rocks of Mesozoic and Tertiary age. Position of volcanic vent near Two Ocean Lake is indicated.
